Phase 1: Exterior Remodel

Phase 2: House Lift and New Foundation

Phase 3: Connect the Old and the New

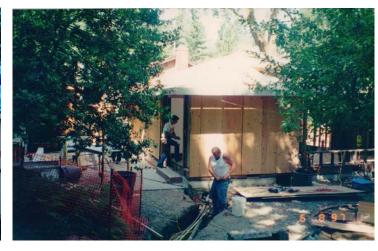
Above left: Furniture was stored tightly in two bedrooms. Utilities were disconnected. A masonry fireplace was demolished and the roof was stripped for seismic strengthening.

Above: The first phase of work began with the house still on its foundation for easy and safe work. Siding was stripped. Window and door framing was modified. New electrical, insulation and shear plywood to walls and roof were installed and inspected.

Above right: Side yard of house with new shear plywood. Underground utilities for the future Studio were completed. The house was ready for Phase 2.

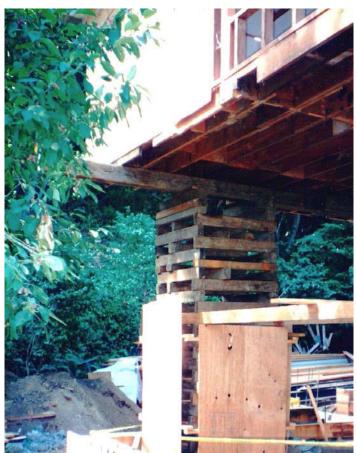
Left: With exterior remodel work roughed in, house was cut loose from the garage and lifted with hydraulic jacks onto wood cribbing. The original foundation was demolished.

Right: A bobcat-mounted drill rig gingerly maneuvered around the timber cribbing, drilling 20 foot deep piers.

Far right: A new concrete grade beam foundation was formed and placed. Foundation work took a grueling 24 days to complete.

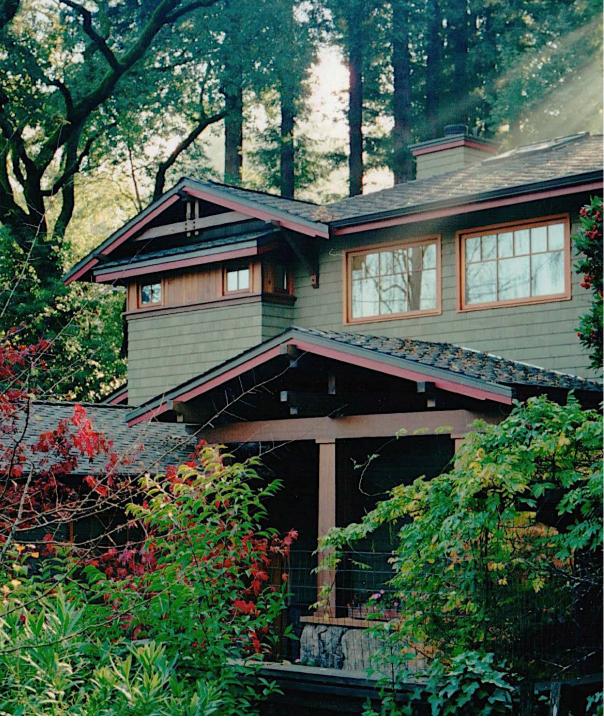
Above: Roofing, windows and shingle siding were Installed over five weeks – days before record rains.

The completed project with custom mix stains applied the following spring

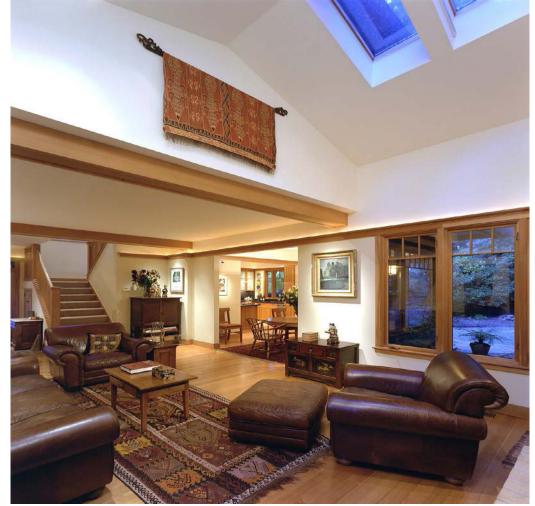
Above: The double height ceiling reveals the original cottage's rear wall. A Doug Fir false beam serves as an insulated plumbing chase for upstairs bathrooms.

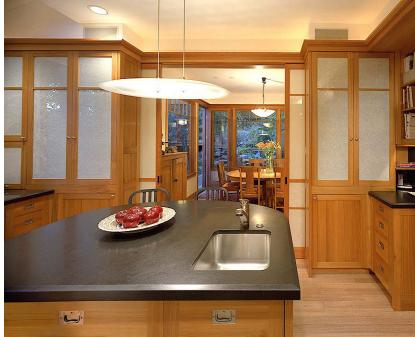
Above: Reclaimed woods, Japanese rice paper sandwiched in glass cabinet doors (for ease of maintenance) and absolute black granite countertops continue an Asian influenced theme.

Reclaimed cypress redwood and Douglas fir was hand selected from sources and milled on site into columns, beams, railings, doors and interior trim.

Master Woodworker, William Eichenberger, a long time friend and collaborator, painstakingly sorted, milled and fitted 400 year-old Louisiana cypress wood salvaged from a Pre-Civil War warehouse. Together they createdthe kitchen within an Asian/ Arts and Crafts theme. Australian gumwood flooring was installed throughout the first floor after curing four weeks in the living room.
